OPERATING EXPERIENCE SUMMARY

Summary 2002-01
January 14, 2002

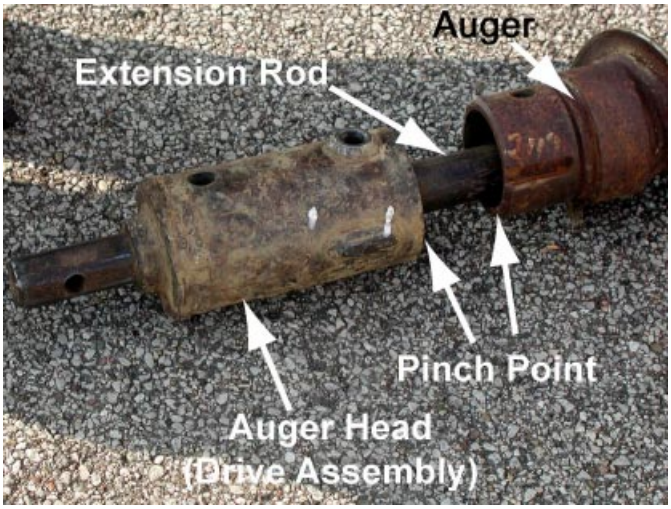
Figure 2. The auger assembly and pinch point

Figure 1 shows the drilling equipment that was being used. At the time of the event, the driller was aligning an extension rod to the threaded rod cap that is nested inside the auger assembly (See Figure 2). The driller used his left hand to actuate the feed valve lever to lower the auger head. The assembly dropped faster than he expected, trapping his right hand in the drive assembly and auger.

Manually aligning the extension rod to the threaded rod cap, which introduces a driller's hand into the pinch point, has been an accepted practice among many drillers and considered in the purview of skill-of-the-craft. The driller was employed by an experienced subcontractor, and oversight by the site contractor, Bechtel Jacobs Company, LLC (BJC), had not included the involvement of a subject matter expert in drilling safety.

Corrective actions recommended by the on-site investigative team are good examples of the items all sites involved in drilling activities should consider. These include:

- BJC will assess all ongoing drilling activities to determine what exposures operators/crew have to pinch points and rotating hazards and verify that adequate mitigation and barriers are in place.

- BJC will revise its subcontracting process to require that contractors submit a comparison of equipment proposed for use against current manufacturer and industry standards to identify non-conformances and compensatory measures. All heavy equipment should contain operating manuals, and daily equipment checks should meet or exceed the requirements in the operating manual. The site should adopt the use of the drill receipt inspection checklist found in the BJC document, *Safety Guidance for Lifting Operations Associated with Drilling, Subsurface Sampling, and Monitoring Well Installation*, December 1994.

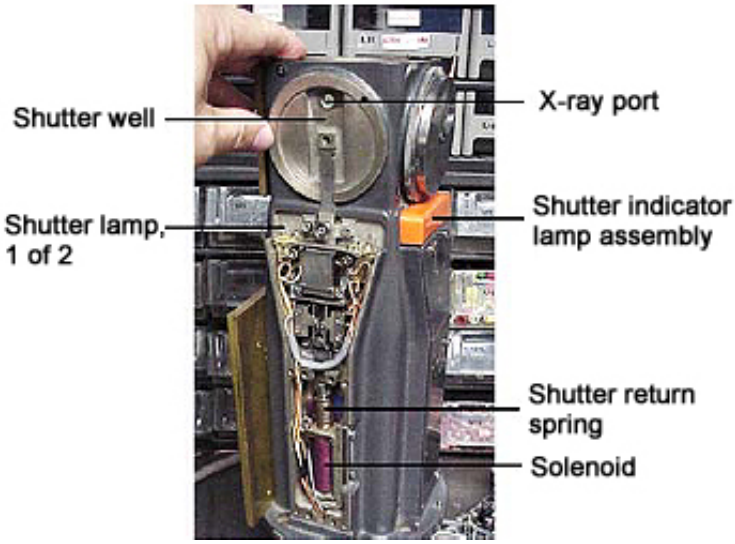
Figure 2. The x-ray tube housing

the spring returns the shutter to the closed position, blocking x-rays escaping from the port in the tube housing (Figure 2).

The lead shutter insert protruded above the sliding surface of the shutter. It is believed to have deformed and loosened, causing uneven wear and binding. Another deficiency associated with lead is the formation of lead oxide, and this oxidation is believed to have caused a stuck shutter in a similar device in April and July of 1993 at Oak Ridge (OE Weekly Summary 93-28, *Personnel Radiation Exposure Caused By X-ray Diffraction Machine Component Failures* (ORPS Report ORO--MMES-X10METCER-1993-0008). Corrosion, however, is not believed to have been a significant factor in the 2001 event.

ORNL corrective actions include replacing the lead-containing shutter with one made of tungsten, adding a set of enclosure door switches to interrupt x-ray generator power, and adding a more visible set of shutter-position indicator lamps.
